A REVIEW ON FAULT ANALYSIS IN UNDERGROUND CABLES

ABSTRACT

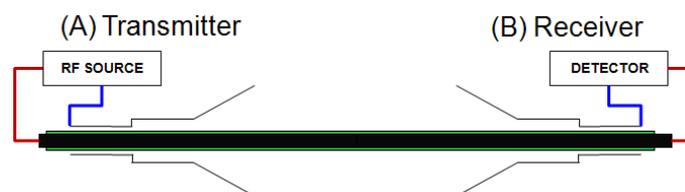
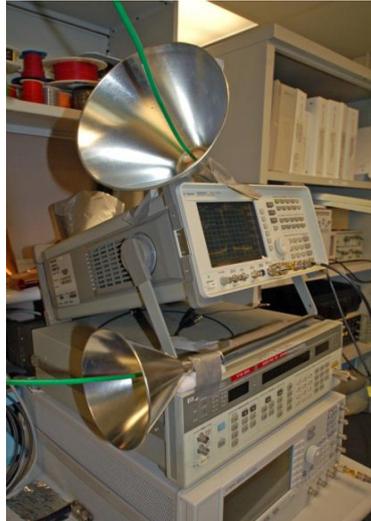
For two - ended detection (Figure5), researchers would couple to the test points at both ends of the cable, launch an RF wave from one end and measure its amplitude at the second end to find the attenuation due to one transit of the cable. For this test, a spectrum analyzer can be used as a narrowband RF detector. Determining the RF phase velocity from the signal at the far end may be possible using a procedure analogous to the resonant

Figure 5 : Two-ended Cable Test Setup Utilizing the Test Points to Launch and Receive the RF Probing Signals
